ACKENHEIL AND ASSOCIATES INC PITTSBURGH PA
NATIONAL DAM INSPECTION PROGRAM. BRESKIN DAM NUMBER 2 (NDI NUMB--ETC(U)
JUL 80 J P HANNAN, J E BARRICK

PHASE I INSPECTION REPORT
NATIONAL DAM INSPECTION PROGRAM

BRESKIN DAM No.2

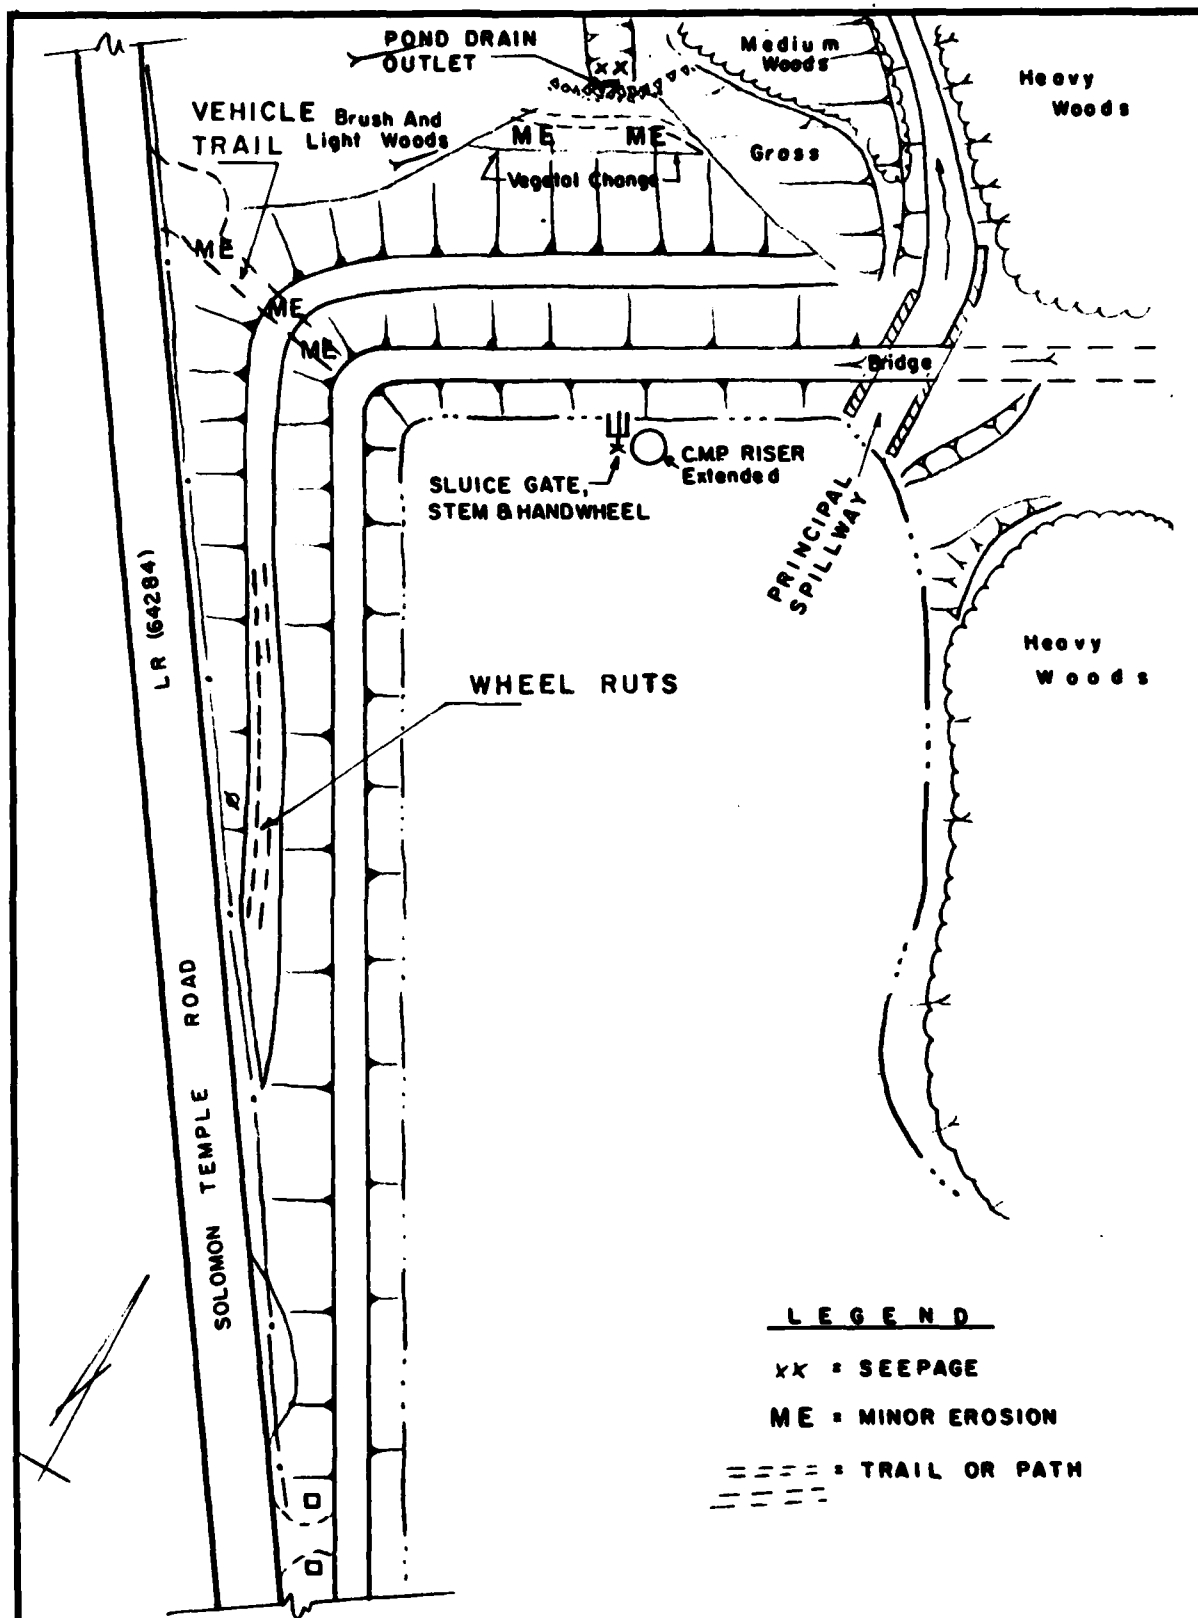
DATE: JULY 1980		BRESKIN DAM No. 2		FIELD PLAN
SCALE: NONE		NATIONAL DAM INSPECTION PROGRAM		
DR: PT	CK: JEB	A. C. ACKENHEIL & ASSOCIATES, INC. CONSULTING ENGINEERS PITTSBURGH, PA., CHARLESTON, W. VA. & BALTIMORE, MD.

XX = SEEPAGE
